MISCELLANEOUS PAPER S-68-26

# CONDITION SURVEY, DAVISON ARMY AIRFIELD, FORT BELVOIR, VIRGINIA

November 1968

U. S. Army Engineer Waterways Experiment Station  
CORPS OF ENGINEERS  
Vicksburg, Mississippi

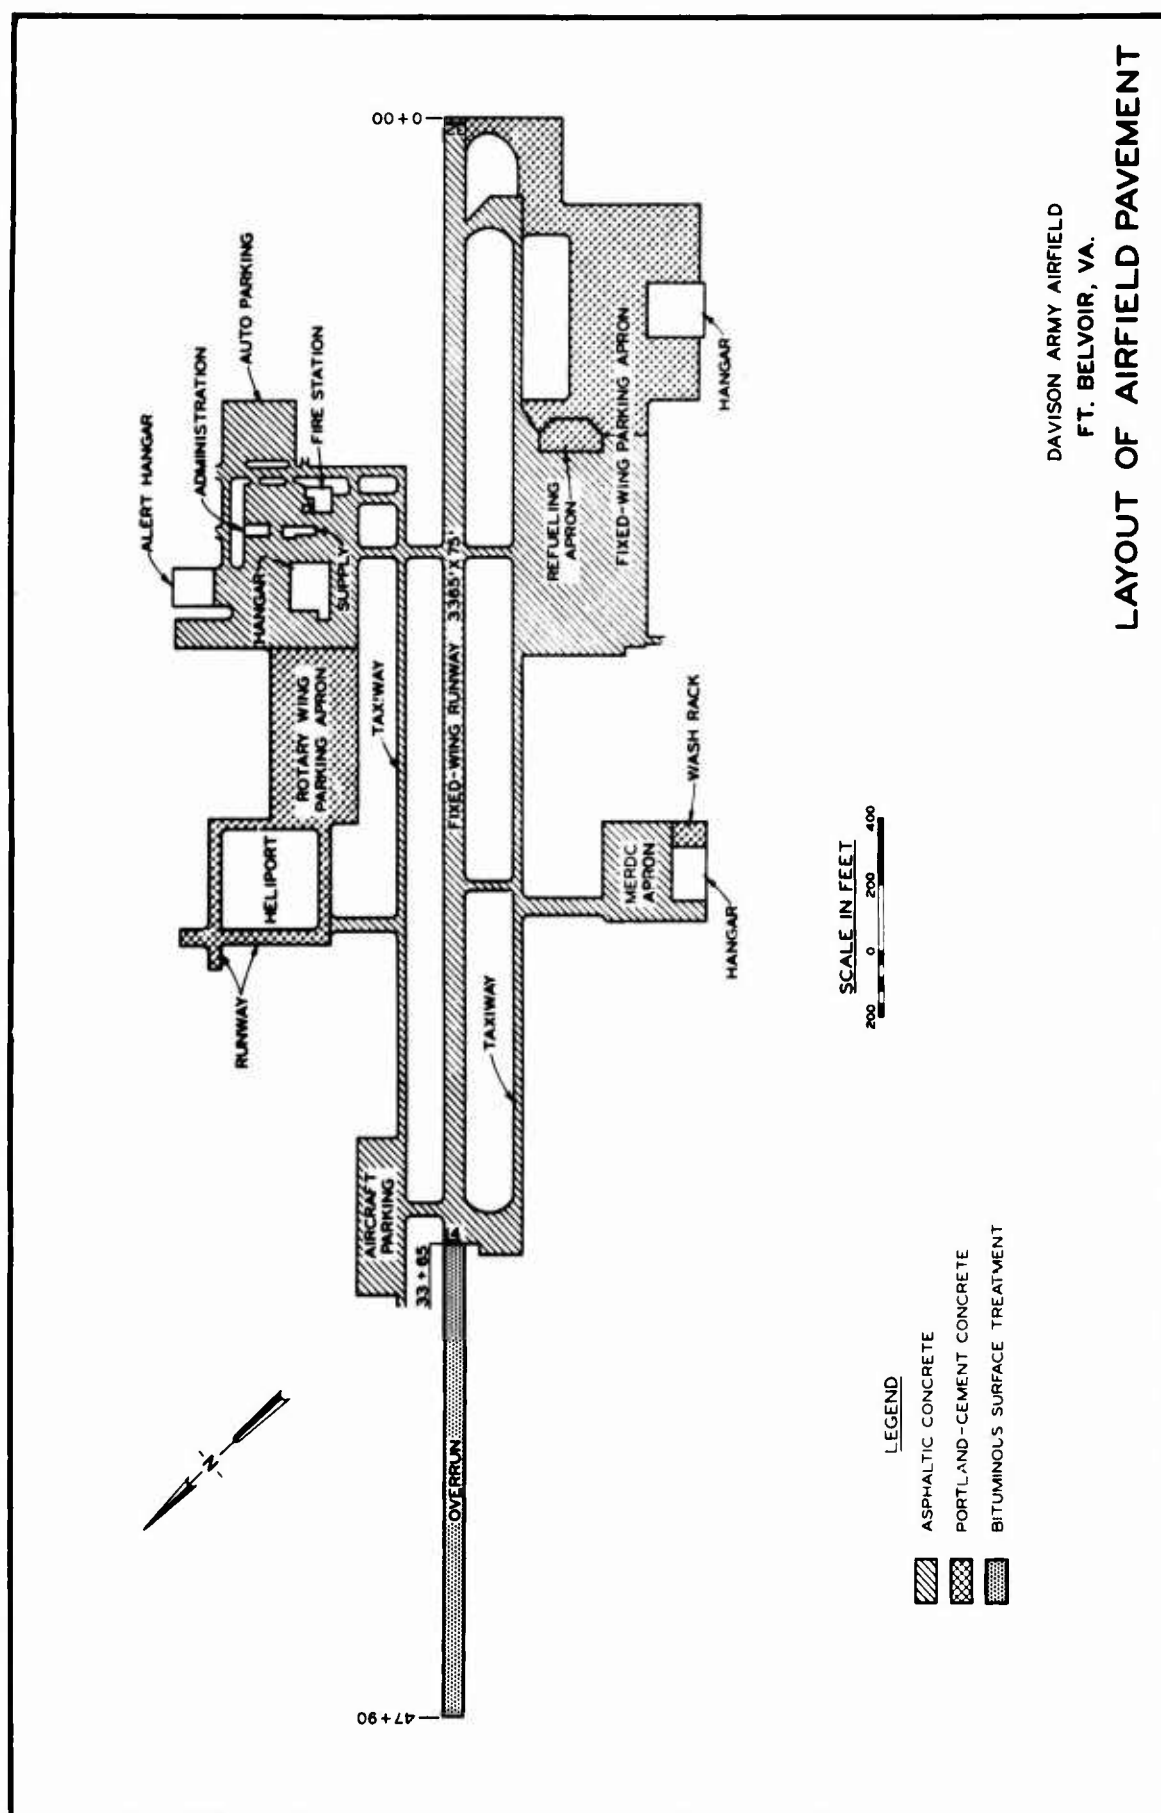
Photograph 5. Taxiway adjacent to heliport area

satisfactory condition. The slurry seal coat placed over the portland cement concrete area was peeling badly (photograph 4). The runways and parking apron in the heliport area were in excellent condition, but the parallel taxiway from the heliport area to the northwest end of the runway was in poor condition (photograph 5).
